DOI: 10.34854/ICPAF.52.2025.1.1.221

ON THE CHEMICAL MECHANISM OF SURFACE DESTRUCTION OF THE DIAGNOSTIC SYSTEM COMPONENTS INSIDE EAST VACUUM VESSEL^{1,2}Lobanova L.G., ¹Wang S., ¹Lian H., ¹Cui X., ¹Chen J., ¹Yan R., ¹Zhang L.,
²Afanas'ev V.P., ¹Liu H.¹*Institute of Plasma Physics, Chinese Academy of Sciences, Hefei, China, lidiia@ipp.ac.cn*²*National Research University "MPEI", Moscow, Russia*

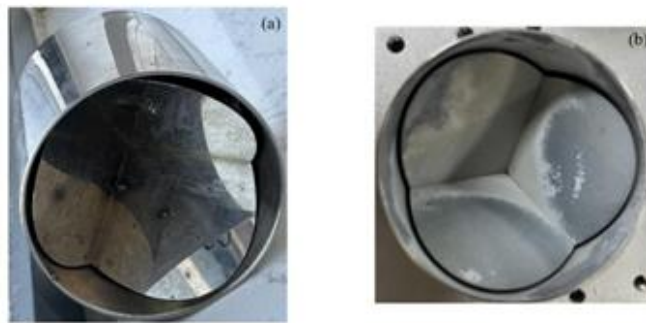
First Mirrors (FMs) are essential plasma-facing components in all optical spectroscopy and imaging systems used for plasma diagnostics both in laboratory applications and in controlled fusion devices. They are first optical elements that face plasma directly and reflect light from plasma to various diagnostic instruments. The condition of FMs directly affects the quality and the reliability of optical measurements in plasma experiments. FMs tests were conducted at JET [1], EAST [2] and other machines. It was established a potential modification of a FMs reflectivity due to erosion-deposition processes during operations. The method of installing FMs in EAST tokamak has practically eliminated the FMs surface destruction due to erosion-deposition processes [3,4]. However, as a result of prolonged operation, surface erosion occurred and reflectivity properties were degraded. In this work causes of significant surface erosion of polycrystalline molybdenum FMs installed in EAST tokamak and operated during two experimental campaigns were investigated. The component and depths profiling analysis has been carried out by means of X-ray photoelectron spectroscopy. The surface analysis showed the dominating presence of molybdenum trioxide MoO₃, with the amounts of B, Zn, Cu, and Fe not exceeding 1%. It was established a predominance of a chemical mechanism of mirror surface erosion due to the growth and evaporation of molybdenum oxides, which have a very high volatility. It should be noted that the boiling temperature of MoO₃ at the pressure about 10⁻⁵ Pa is about 800°C [5]. Active oxidation of molybdenum occurring during technical breaks and subsequent heating of the mirror to a temperature of about or more than 1000°C at a pressure of a level of 10⁻⁵ Pa led to the evaporation of molybdenum trioxide MoO₃. Repeating the specified process multiple times during the operation of the EAST tokamak led to the development of significant macrotopography on the surface of the FM, as shown in Fig. 1 (b).

Fig. 1. EAST FMs before (a) and after (b) operation
